Vancouver Island Community Flow Monitoring Network Pilot Project

STATION SUMMARIES

2022-23

Prepared by Thea Rodgers, Junior Biologist
British Columbia Conservation Foundation
Nanaimo, BC

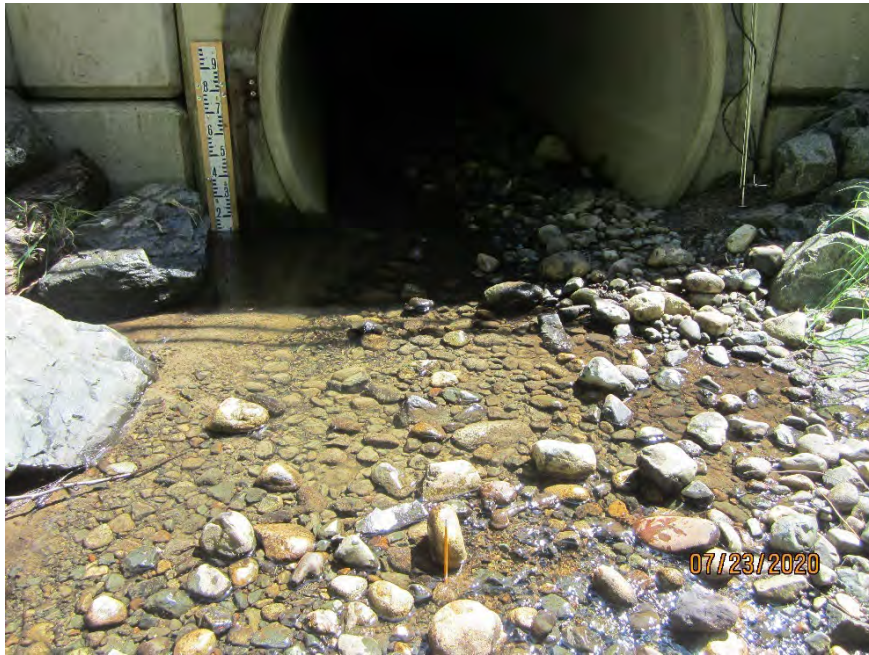
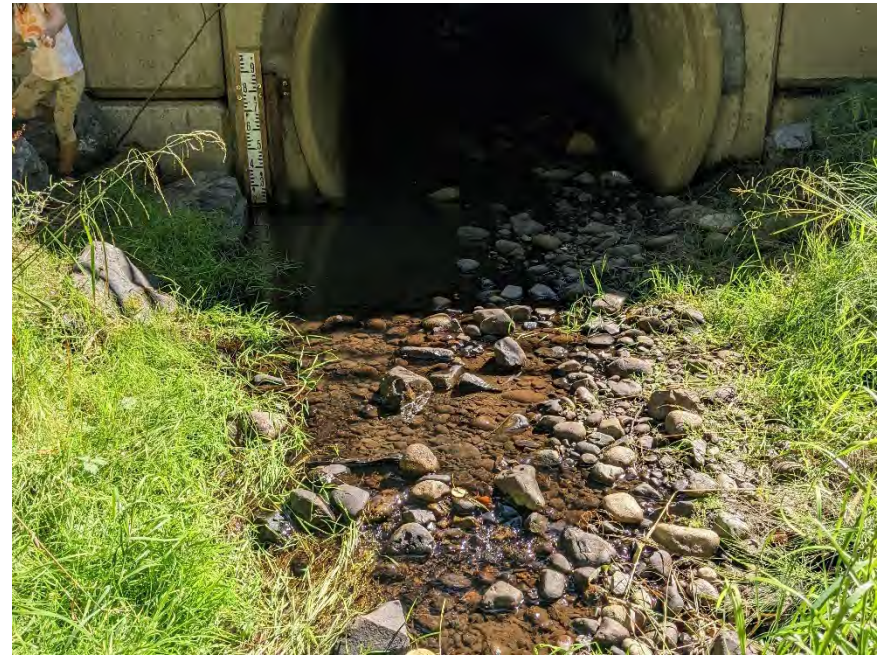
The Beach Creek station was first installed on July 23, 2020 by BCCF and the Qualicum Beach Streamkeepers (QBSK) downstream of the Hemsworth/Chester Road – Village Way walking path. The logger is mounted on the downstream face of the walking path culvert, which was replaced by the Town of Qualicum Beach in 2015-16.

Figure 3. Beach Creek logger in July 2020 (Left) and August 2022 (Right).

More consistent notes should be kept about the clearing of debris before and after logger download. This site is prone to accumulation of silty sand and organic debris in and around the logger pipe, which has caused issues with logger stability in the past. The aircraft cable attachment could also be swapped out for a more stable mounting system (e.g., PVC pipe, aluminum T-post) which would not be as susceptible to movement with sediment deposition.

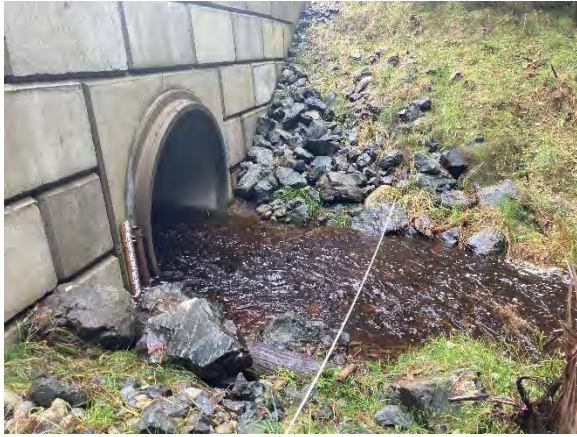
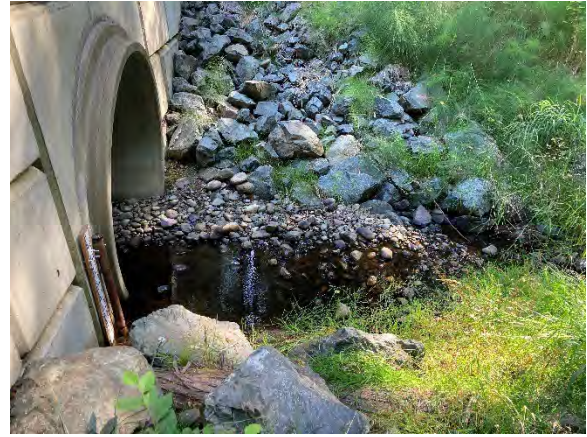
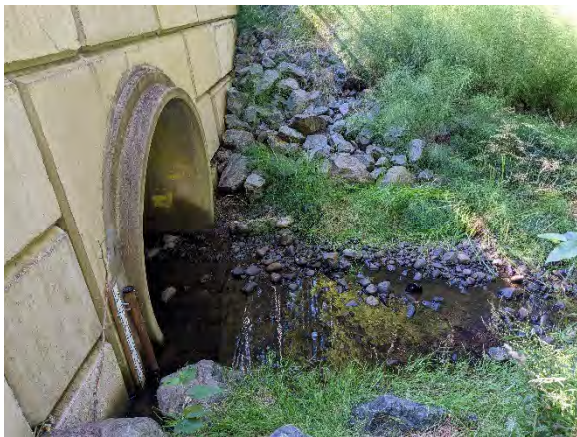
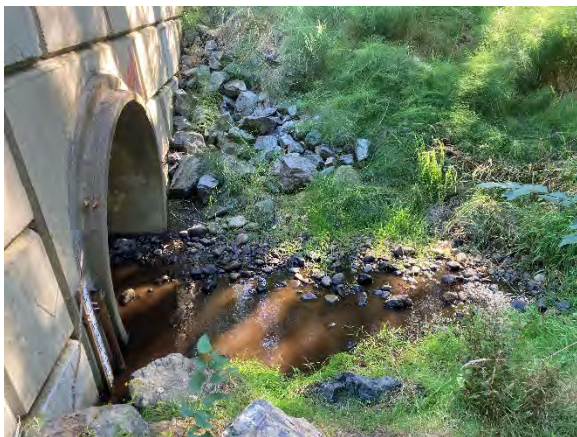
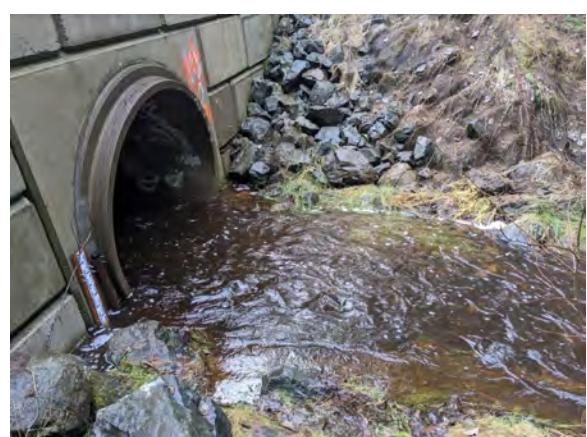
Figure 5. Beach Creek, looking across station from right bank towards Village Way.

November 20, 2020 / High Flow Section Control

August 17, 2021 / Low Flow Section Control

July 28, 2022 / Low Flow Section Control

September 20, 2022 / Low Flow Section Control

December 26, 2022 / High Flow Section Control

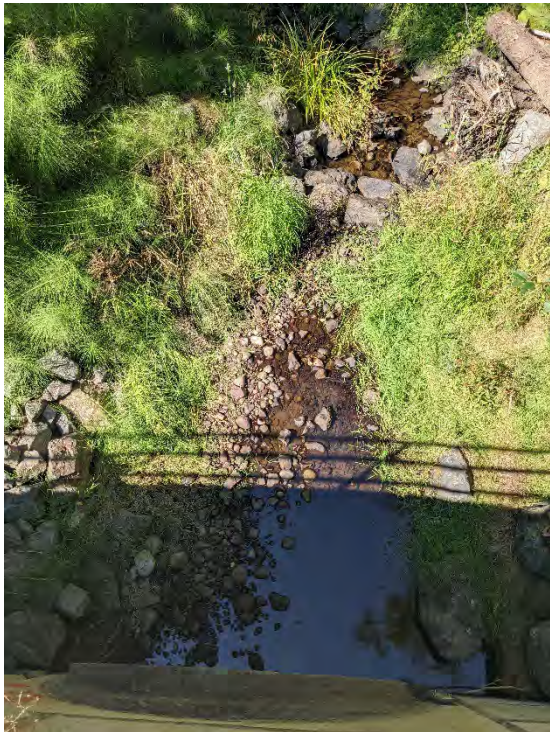
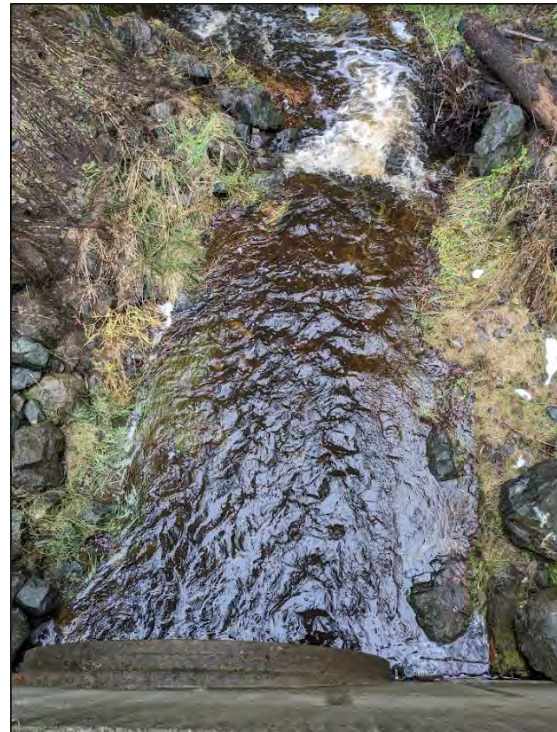
August 17, 2021 / Low Flow Section Control

July 28, 2022 / Low Flow Section Control

August 24, 2022 / Low Flow Section Control

December 26, 2022 / High Flow Section Control

Figure 6. Beach Creek, looking downstream at control from walkway above station.

The station could be moved upstream to the deep pool below the Village Way culvert (where bucket measurements are conducted) if low flow conditions continue to impact the logger data quality; however, the pool also has a mobile control. New benchmarks and a new rating curve would need to be established. Moving the station is recommended only if site challenges severely impact data quality and/or drying of the sensor occurs.

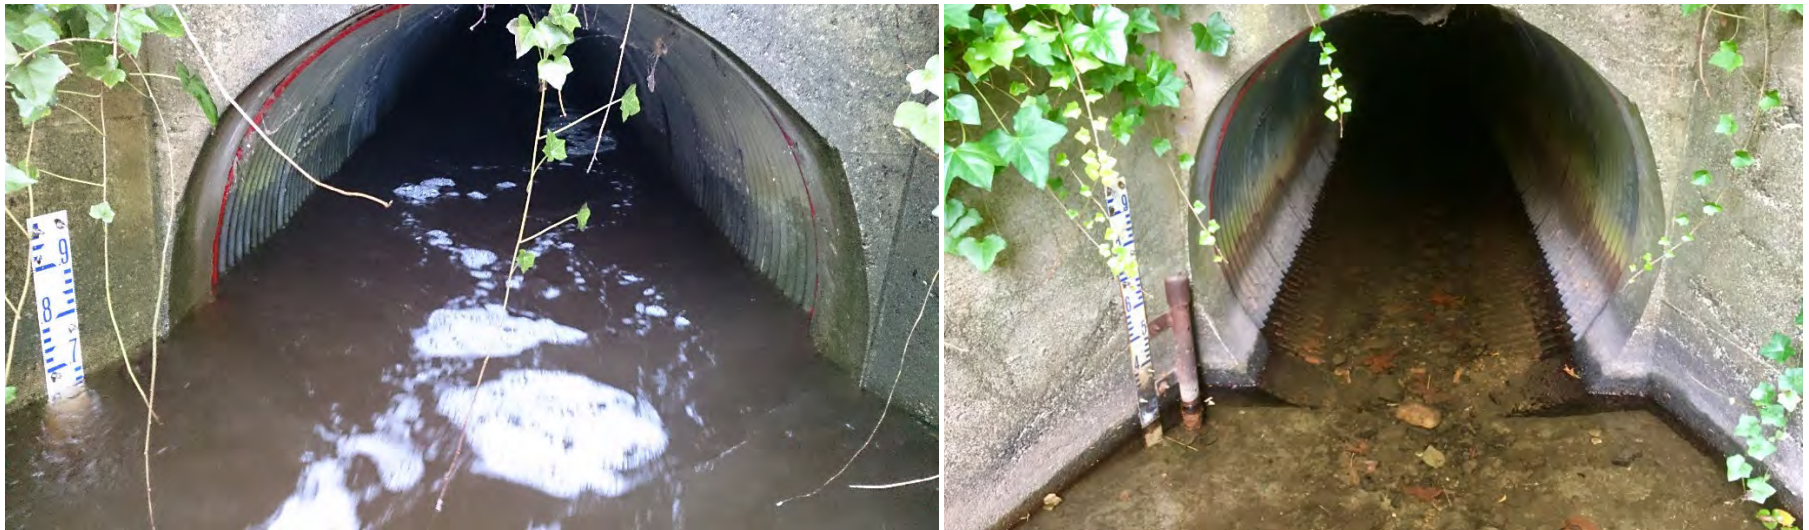
Figure 10. Grandon Creek logger in February 2014 (Left) and November 2022 (Right).

More consistent notes must be kept about the clearing of debris before and after logger download. This site is prone to accumulation of small gravel in and around the logger pipe, which has caused issues with logger stability in the past. Deposition will always occur at this site.

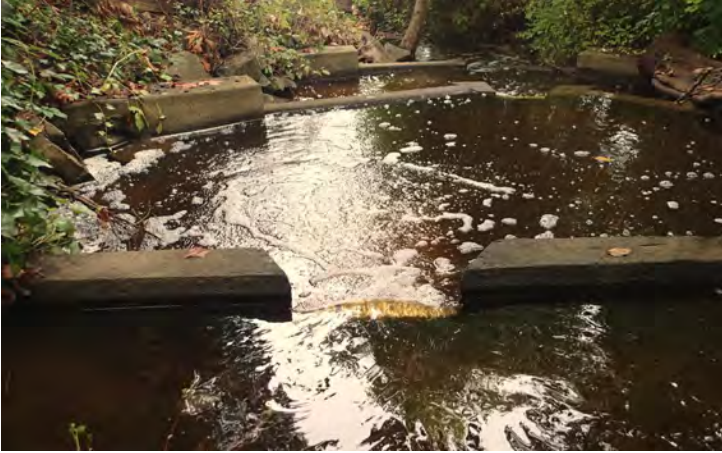
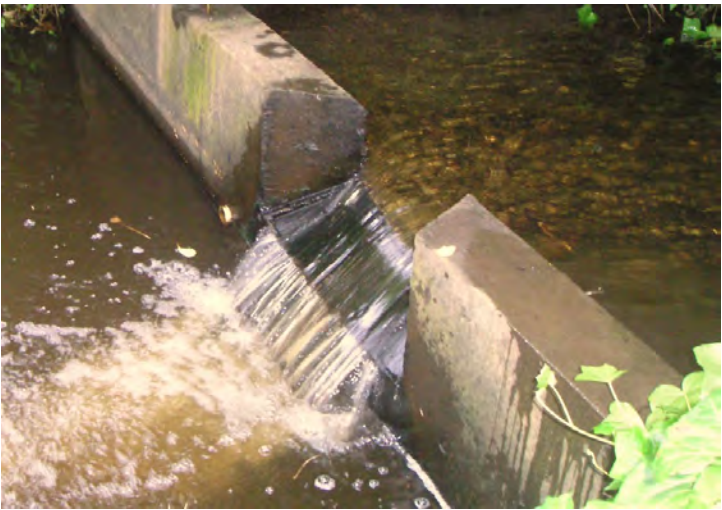
October 3, 2013 / Low Flow

June 25, 2013 / Low Flow

Figure 12. Grandon Creek, looking a) downstream at control from culvert mouth next to station (top); b) at control notch from left bank wing wall (bottom) (side-by-side views from similar angles).

Written descriptions of the control condition and photographs from the same upstream and downstream views of the weir should be collected at every site visit. Specific photo points should be established, e.g. from the pool below the station looking directly upstream at the weir notch (cannot be accessed during high flow), or from left- or right-bank wing wall looking downstream (could be accessed even at high flow). Review historical photos for reference.

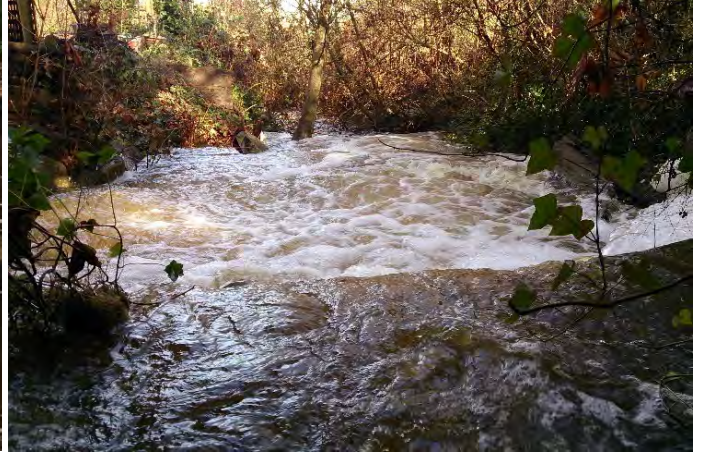
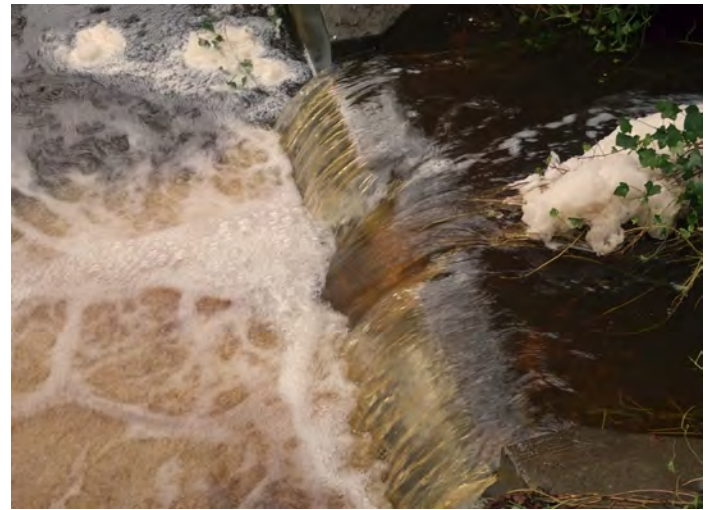
February 17, 2014 / High Flow

December 19, 2014 / Moderate Flow

The substrate in the vicinity of the logger is primarily cobbles, small gravel, sand and silty mud, which is prone to deposition near the logger. The reach is straight through the culvert but sinuous upstream and downstream (Figures 12-14). The creek supports cutthroat and coho fry and parr, and some adult spawners have previously been observed in the fall (D. James, pers. comm, 2021). At summer low flows, the weir notch makes upstream fish passage difficult to impossible, but downstream passage is possible. In summer, the weir pools serve as deep shaded habitat.

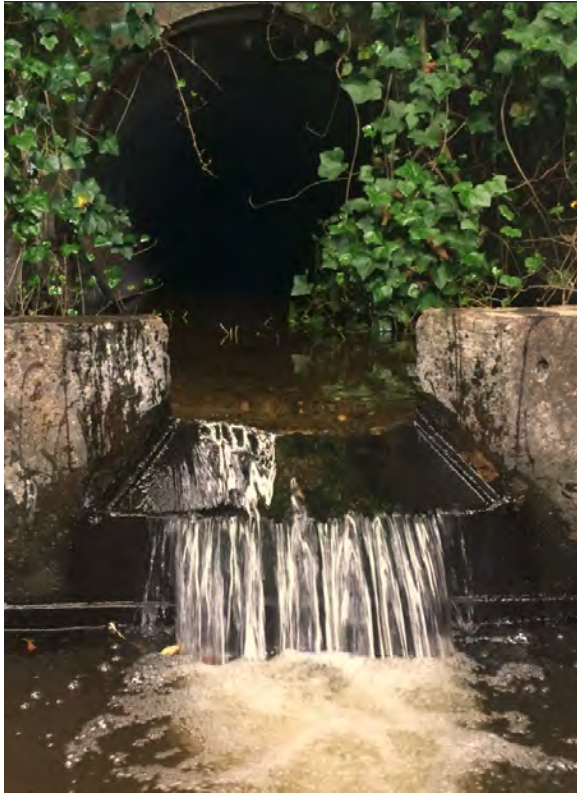
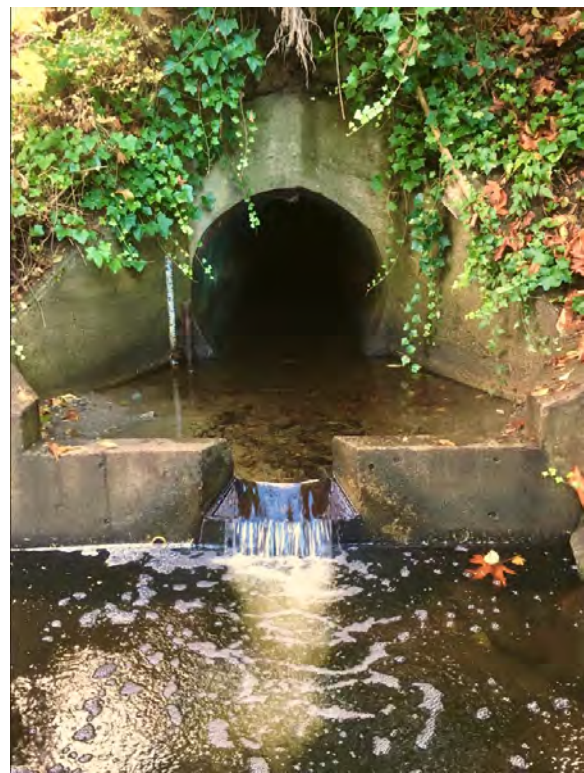
Figure 13. Grandon Creek, looking upstream at control from second weir step-pool.

June 13, 2017

November 25, 2022

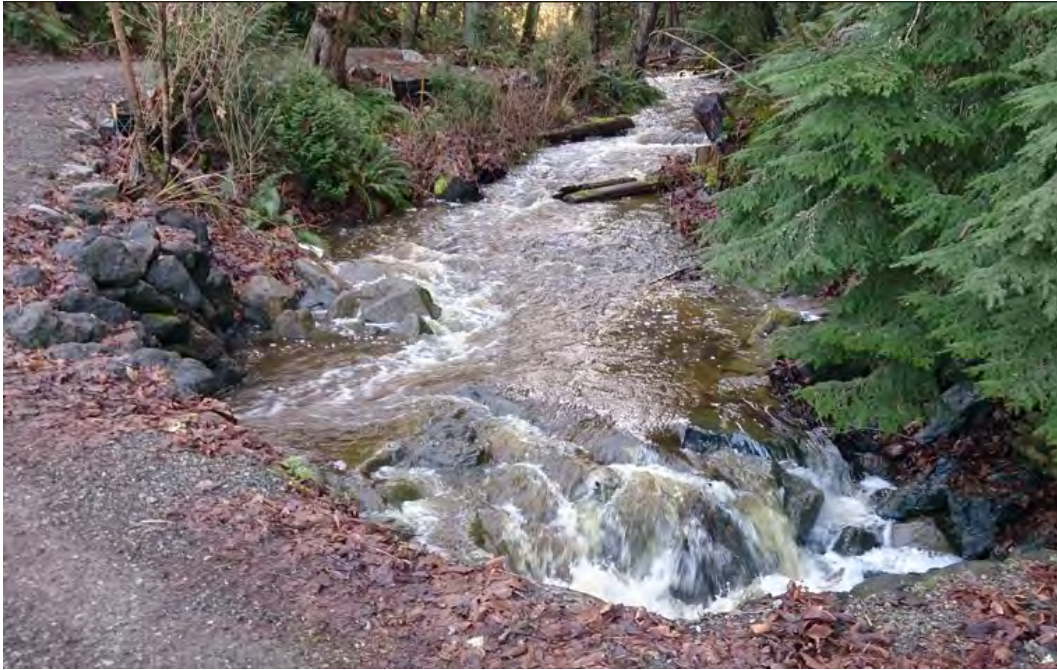
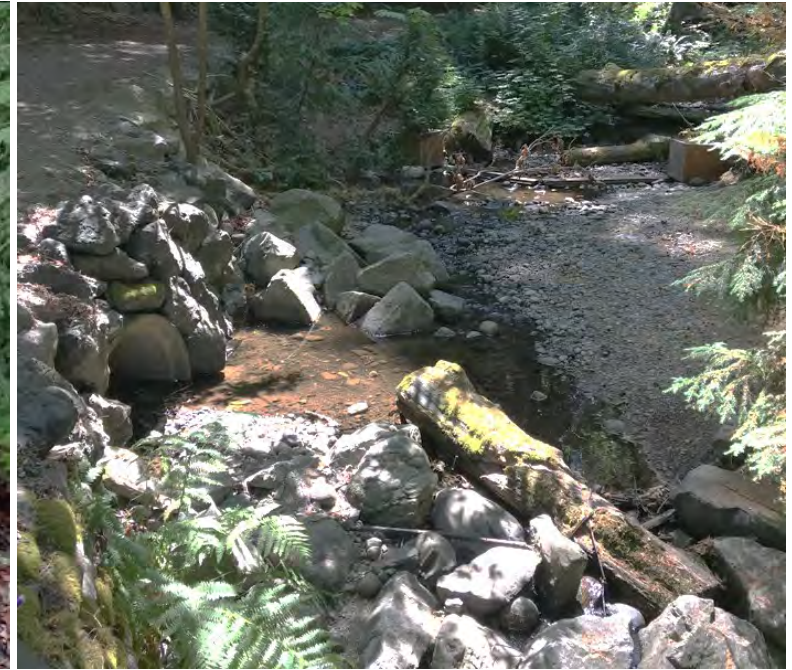
February 17, 2014 / High Flow

Figure 14. Grandon Creek, upstream of Crescent Rd W and gauging station, looking a) upstream from park walking trail entrance before culverts (top); b) downstream at secondary culvert under walking trail entrance (side-by-side views from similar angles).

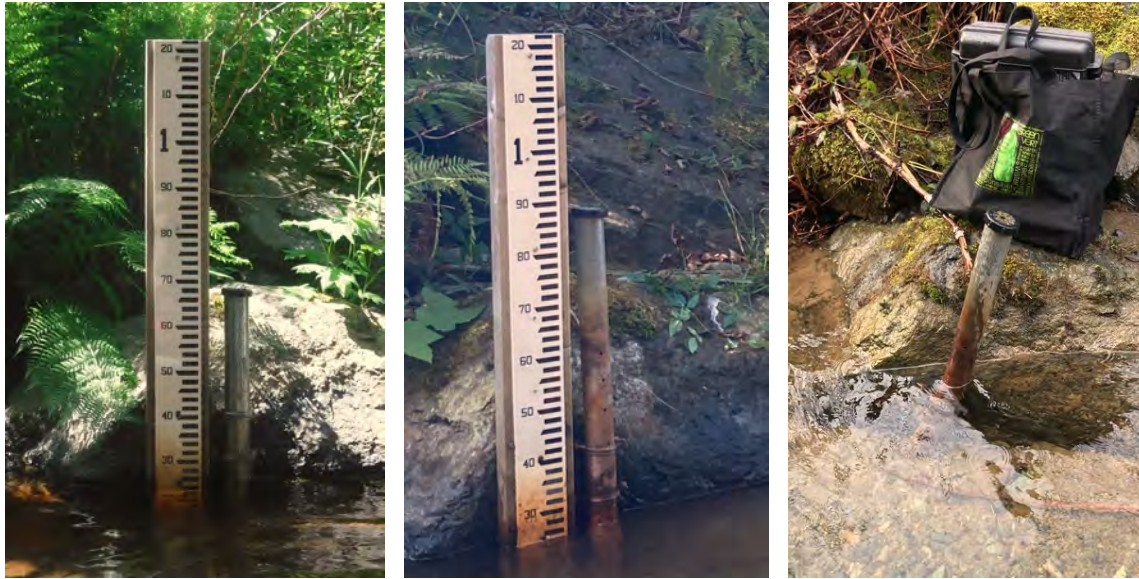
The ~1.2 m reference staff gauge was pre-existing (installed by MOTI). The gauge was buckling due to wear and was re-mounted flush with the back panel in July 2022. Four benchmarks were installed with the logger in July 2022 and surveyed on the same day. They were re-surveyed within +/- 3 mm of the original established elevations in October 2022. Most of the benchmarks are located near the logger, although the primary benchmark is located downstream of the logger on the left bank bridge footing. The staff gauge was lost during a storm in winter 2022 (and BM4 with it). The staff gauge requires replacement during low water. Until it can be replaced, BM2 can be used as a submerged reference point.

Figure 18. Cook Creek logger housing in May 2019 (Left), July 2022 (Center), and February 2023 after loss of staff gauge (Right).

More consistent notes must be kept about the clearing of debris before and after logger download. This site is very prone to accumulation of small gravel in and around the logger pipe, which has caused issues with logger stability in the past. The aircraft cable attachment could also be swapped out for a more stable mounting system (e.g., aluminum T-post) that wouldn't be as susceptible to moving upwards with sediment deposition. Deposition will always occur at this site.

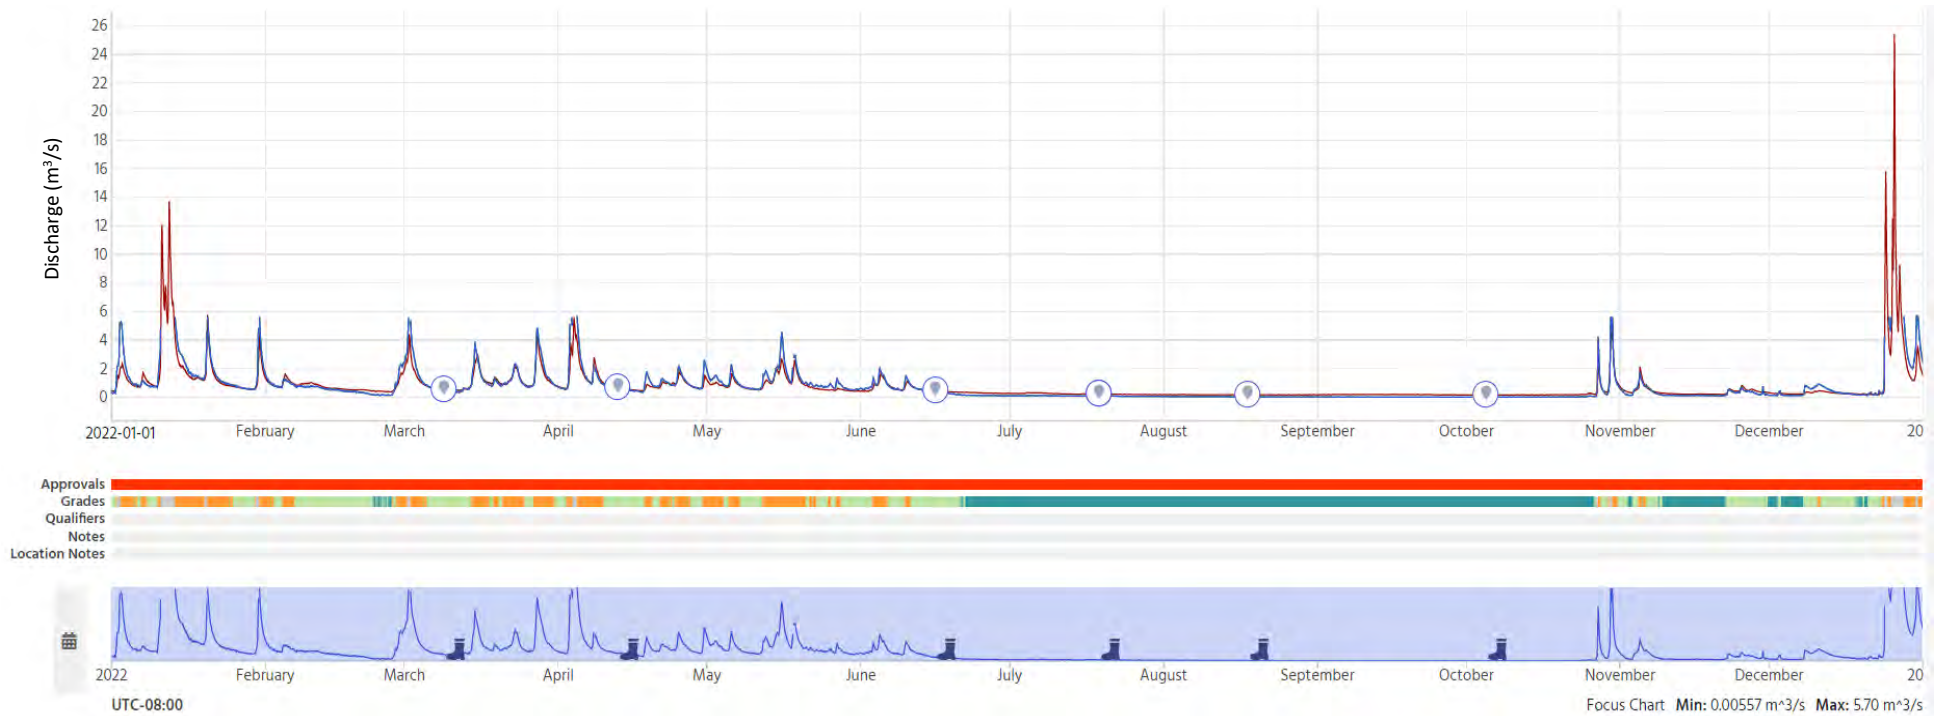
Figure 19. Cook Creek discharge data for 2022 (in blue), calculated using the active rating in Aquarius (PROVISIONAL DATA). Nile Creek for comparison (in red).

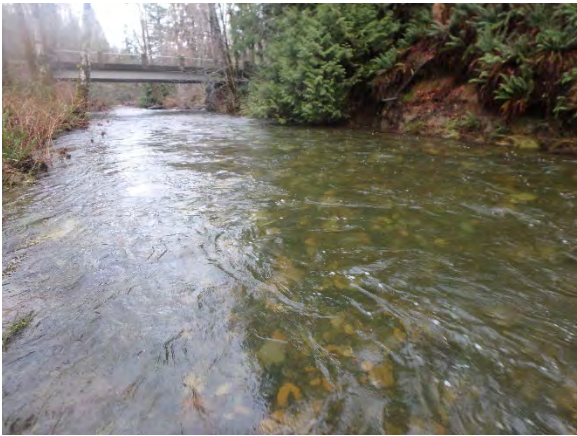
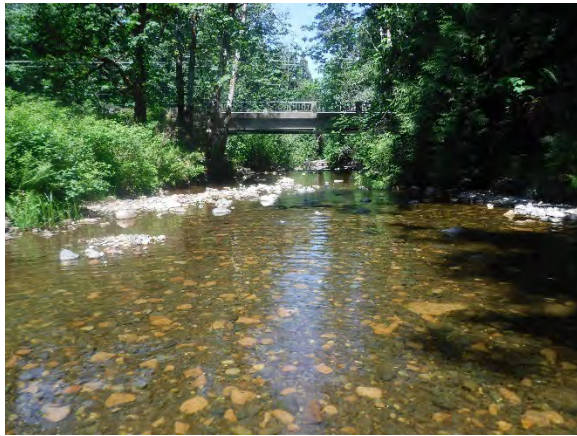
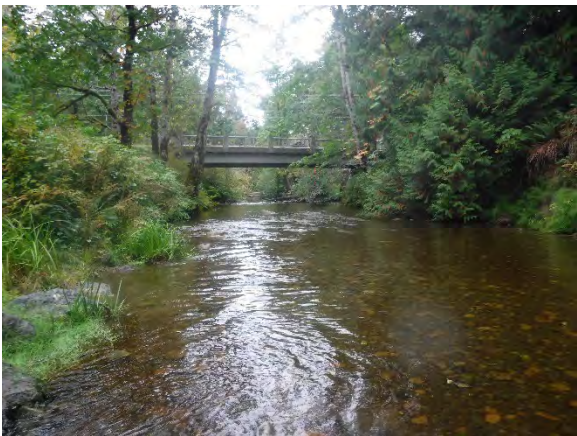
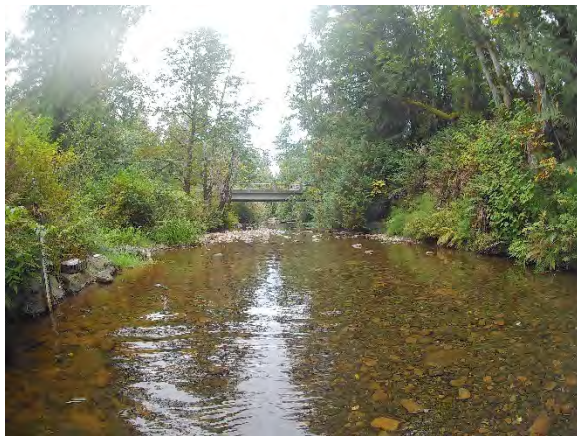
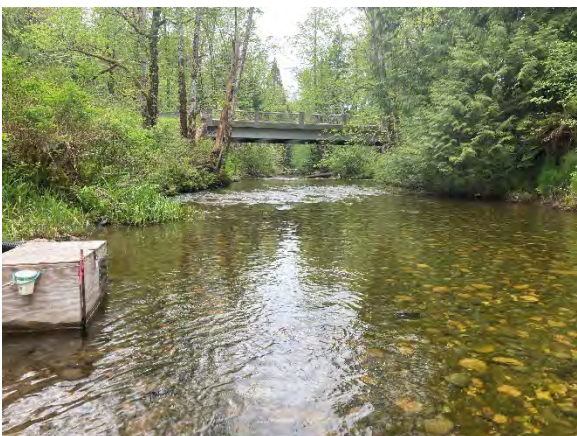
Figure 20. Cook Creek, looking downstream from near gauging station towards Hwy 19A bridge.

November 30, 2017 / Channel Control

May 30, 2019 / Low Flow Section Control

September 19, 2019 / Moderate flow section control

September 22, 2020 / Low Flow Section Control

May 24, 2022 / Moderate flow section control & smolt trap (left)

The station's section control is a riffle located approximately 10-15 m downstream from the station. This riffle is quite shallow in late summer and is influenced by a large overhanging cedar tree on right bank. The Low Flow Section Control is characterized by a dry gravel bar along left bank, and a very shallow riffle on right bank where the point of zero flow (PZF) is located. The Low Flow Section Control accumulates leaf litter in late fall while water levels are low, which can influence the control condition and causes variable rating shifts. The Moderate Flow Section Control is characterized by a fully submerged riffle, which still influences the gauging equipment but is less prone to influences of the cedar tree on right bank or low-flow conditions. Channel control occurs at stages > 9.5 m, where the section control is completely submerged; channel control extends to roughly the highway bridge.

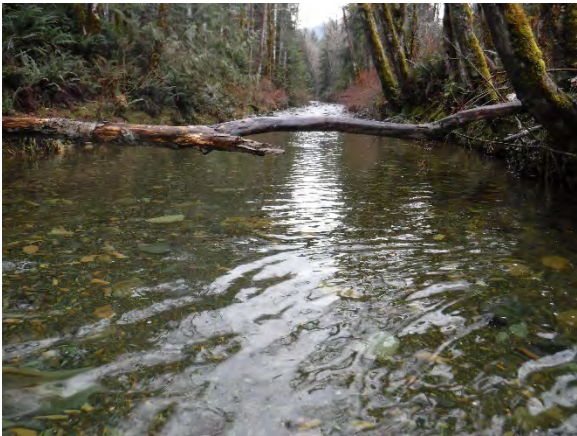
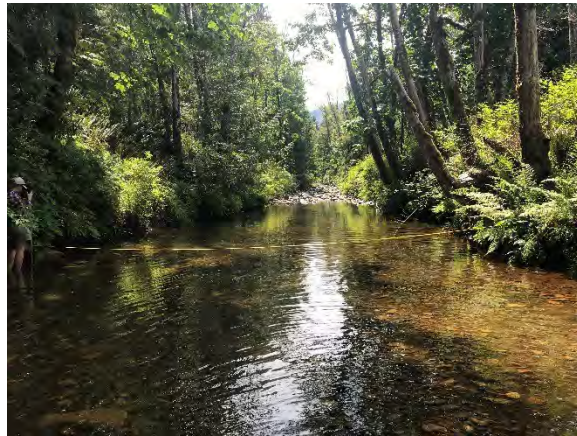
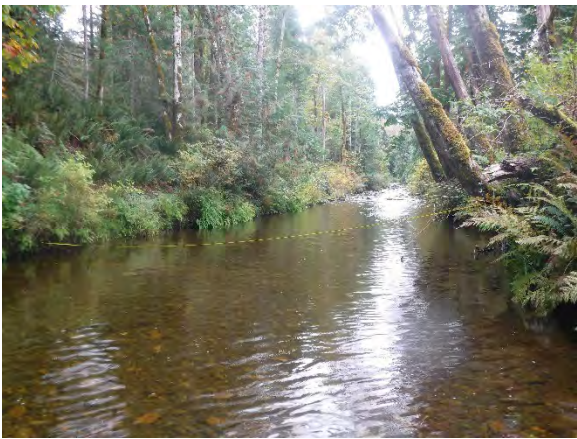
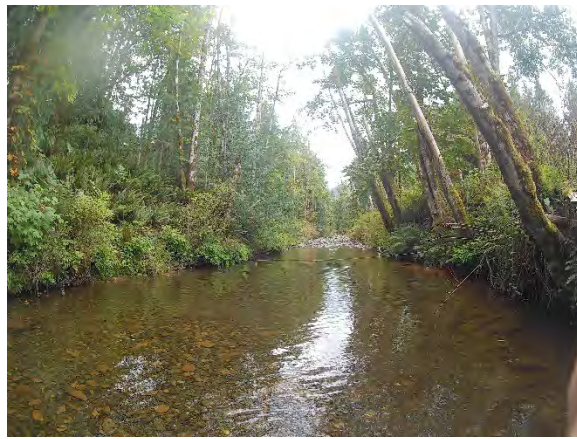
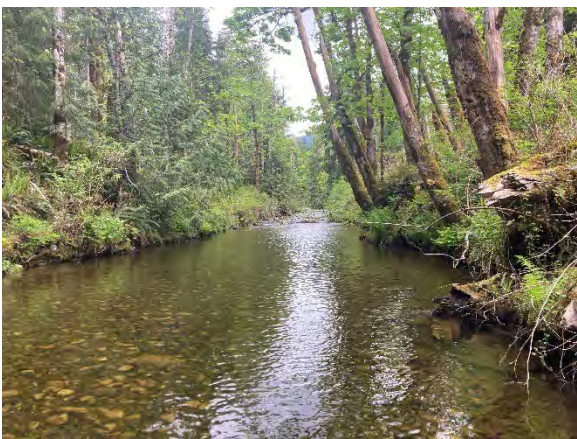
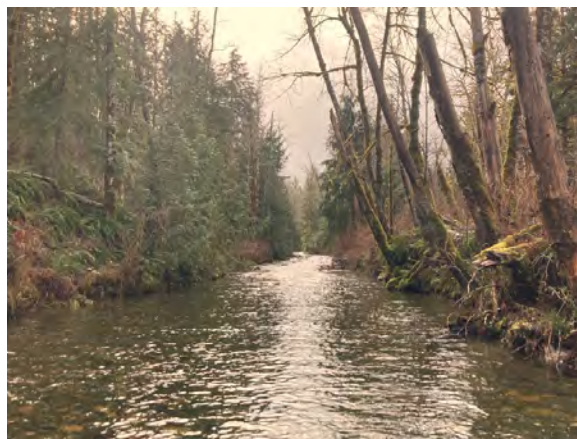
Figure 21. Cook Creek, looking upstream from near station.

December 4, 2018 / Moderate Flow

July 22, 2019 / Low Flow

September 9, 2019 / Moderate Flow

September 22, 2020 / Low Flow

May 24, 2022 / Moderate Flow

February 6, 2023 / Moderate Flow

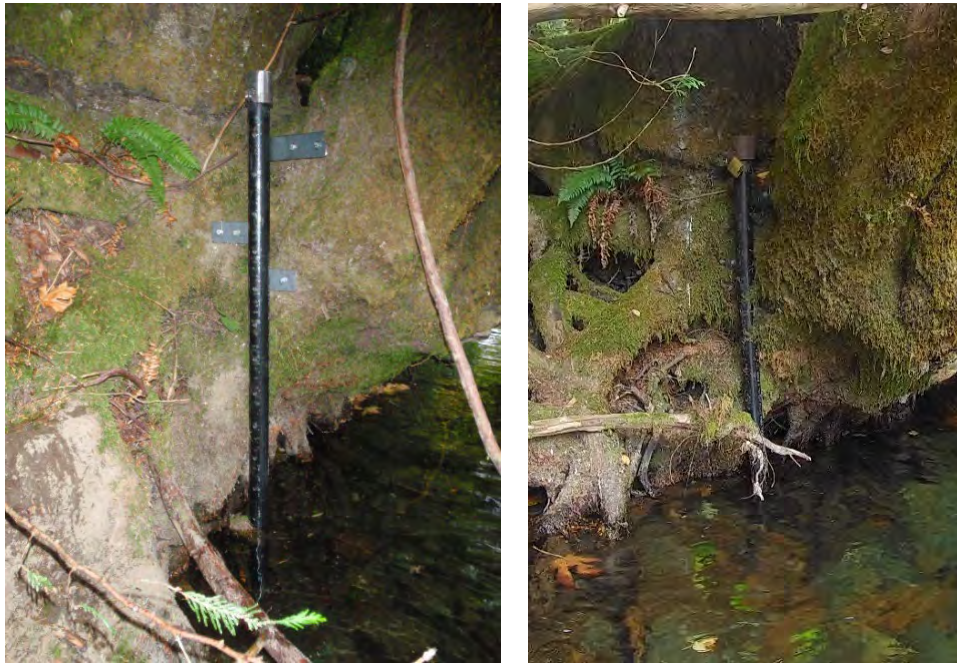
Figure 25. Rosewall Creek logger housing in October 2012 (Left) and September 2020 (Right).

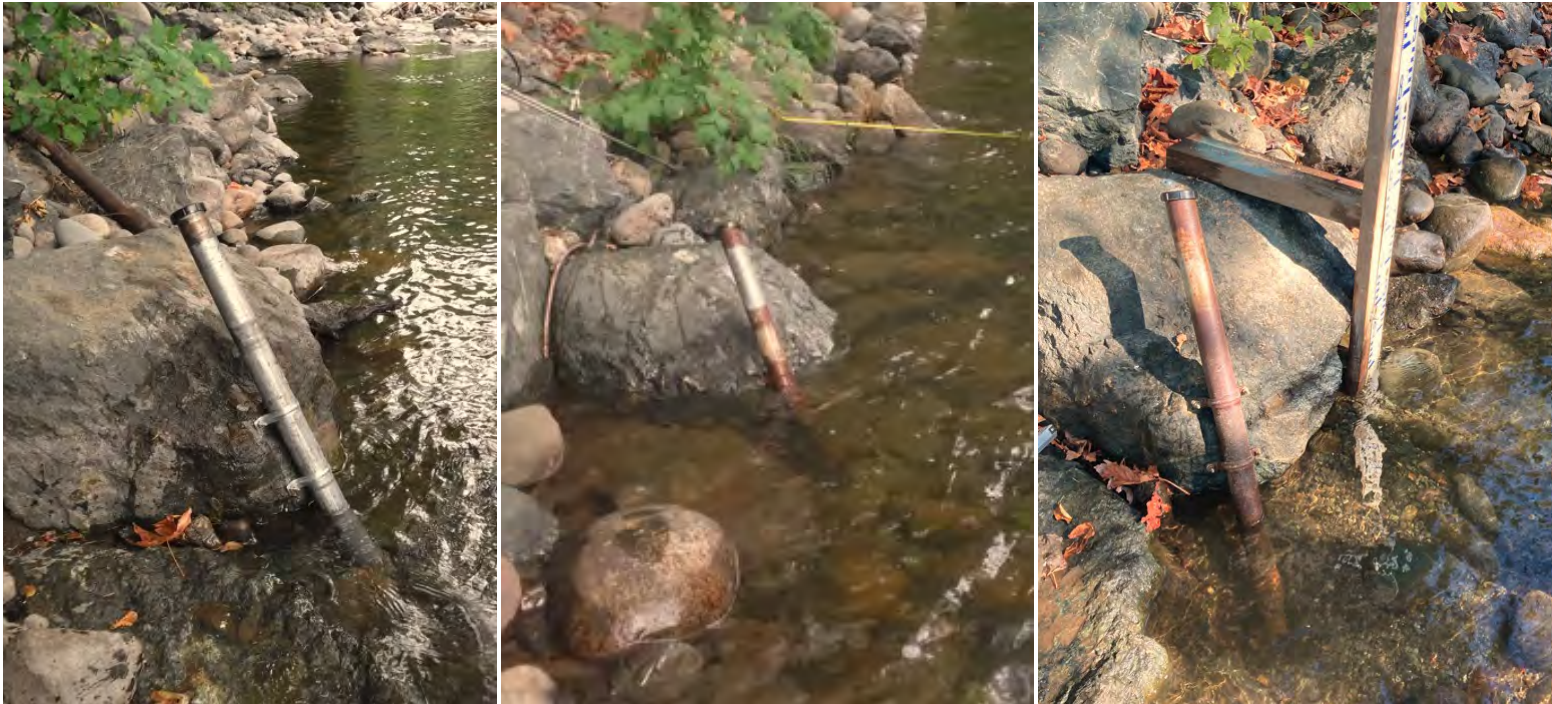
Figure 32. Wilfred Creek logger housing in August 2018 (Left), September 2019 (Center) and February 2023 (Right).

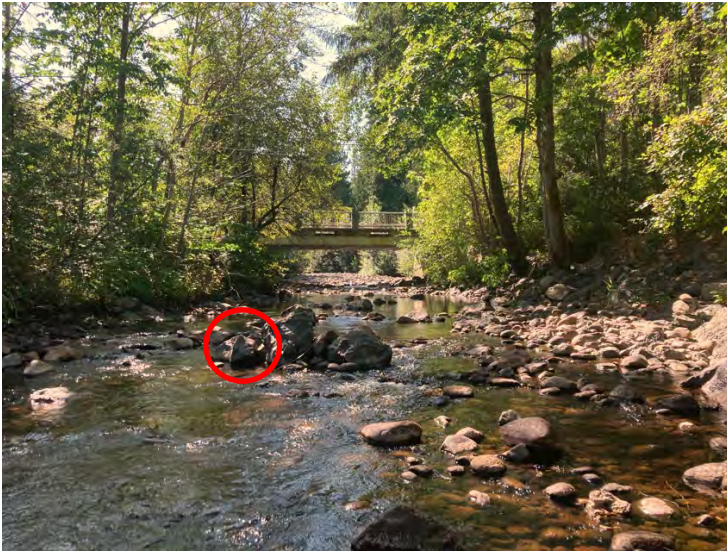
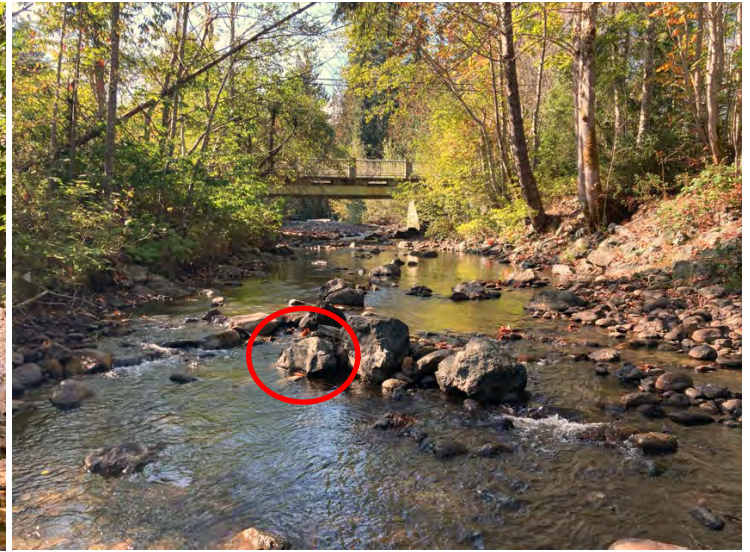
Figure 34. Wilfred Creek, looking upstream from the tip of the riprap cascade towards the Hwy 19A bridge (same rock is circled).

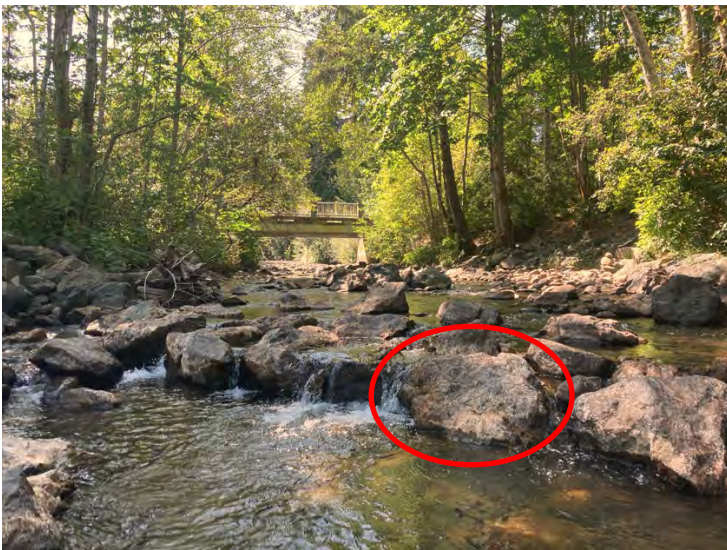
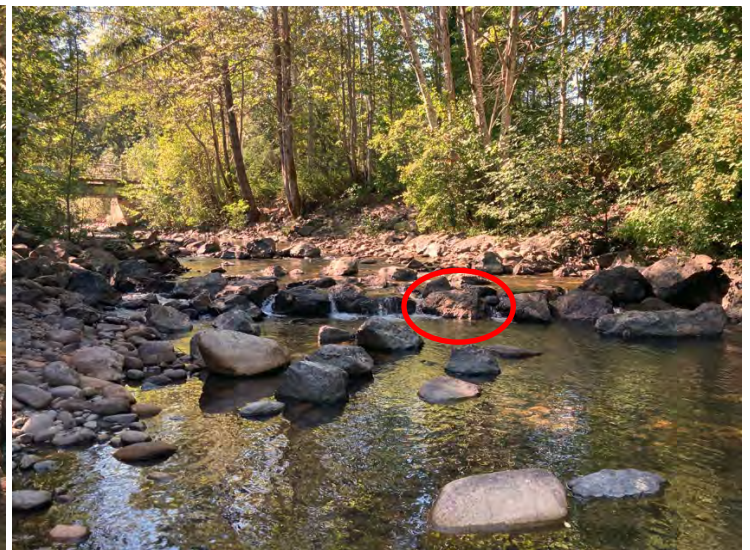
Figure 35. Wilfred Creek, looking upstream from below the riprap cascade towards the Hwy 19A bridge (same rock is circled).

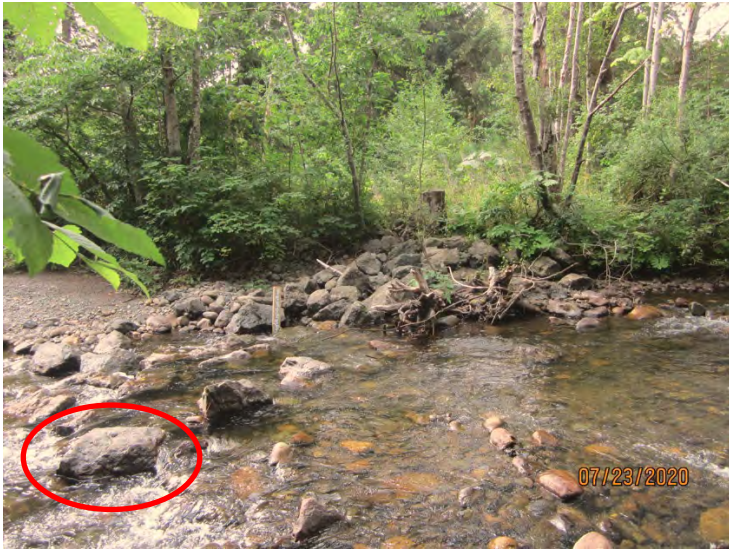
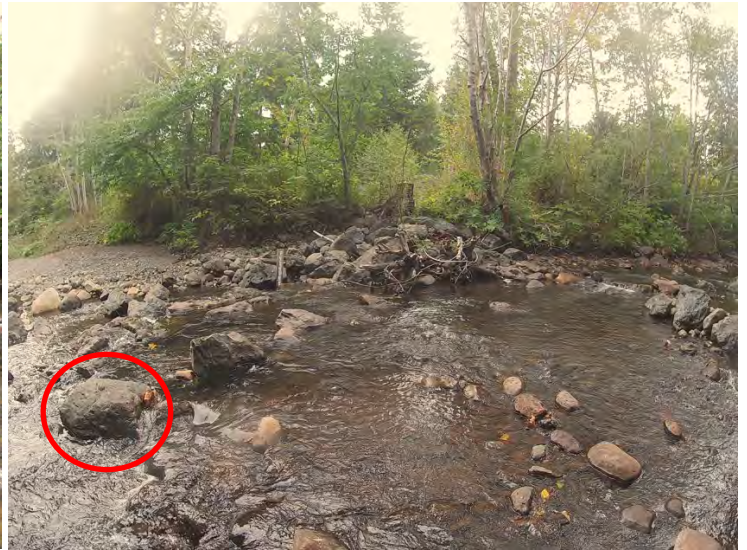
Figure 36. Wilfred Creek, looking from left bank across to right bank at the riprap cascade (same rock is circled).

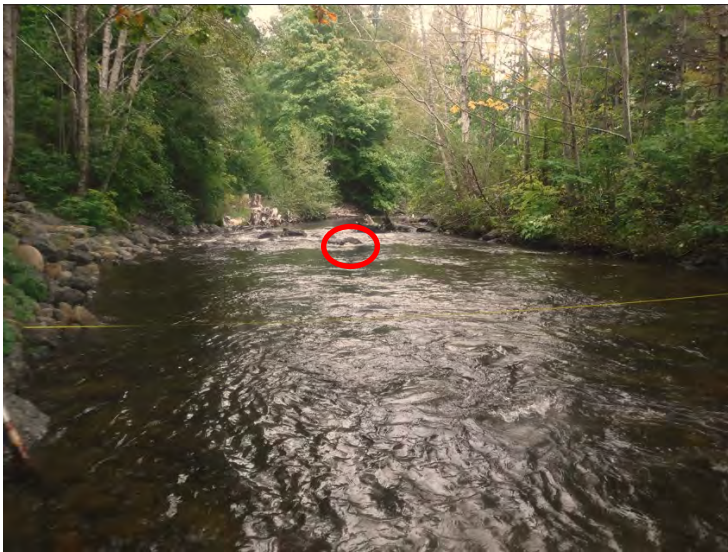
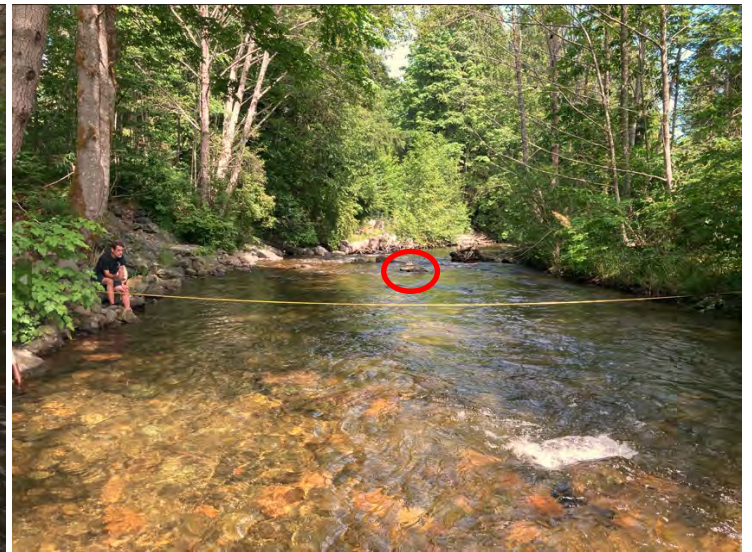
Figure 37. Wilfred Creek, looking downstream from near station towards control (same rock is circled).

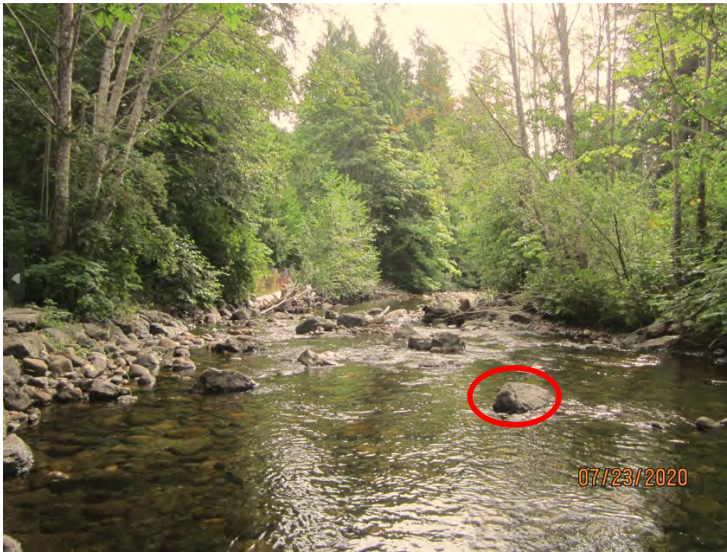
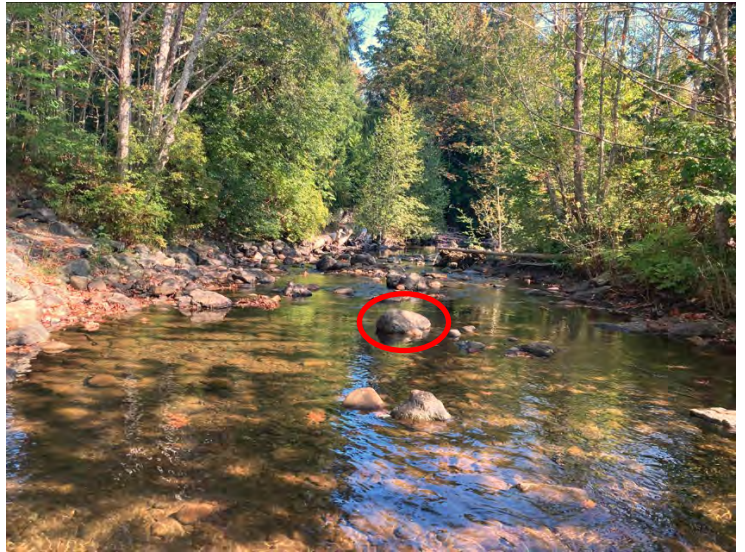
Figure 38. Wilfred Creek, looking downstream from below station towards control (same rock is circled).

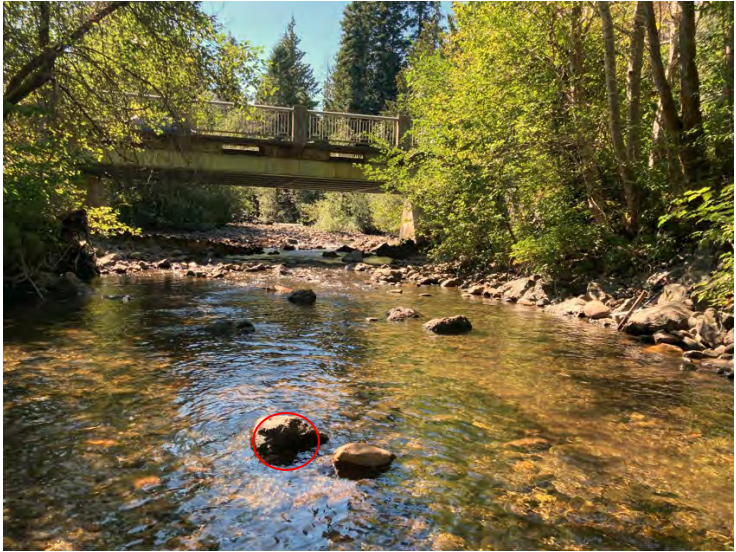
Figure 39. Wilfred Creek, looking upstream from below station towards Hwy 19A bridge (same rock is circled).

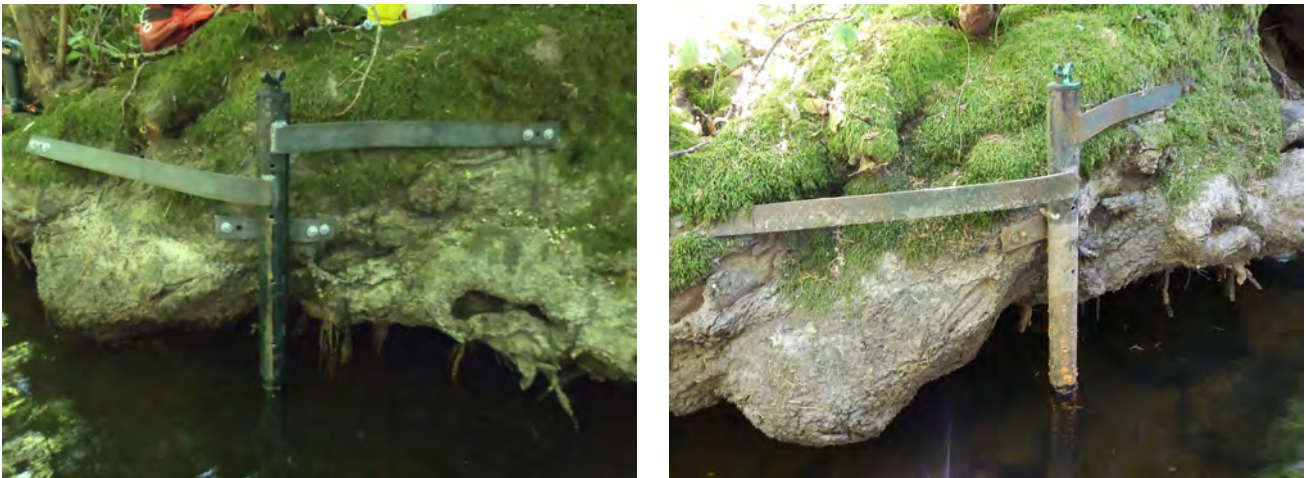
Figure 43. Black Creek logger housing in August 2012 (Left) and July 2017 (Right).

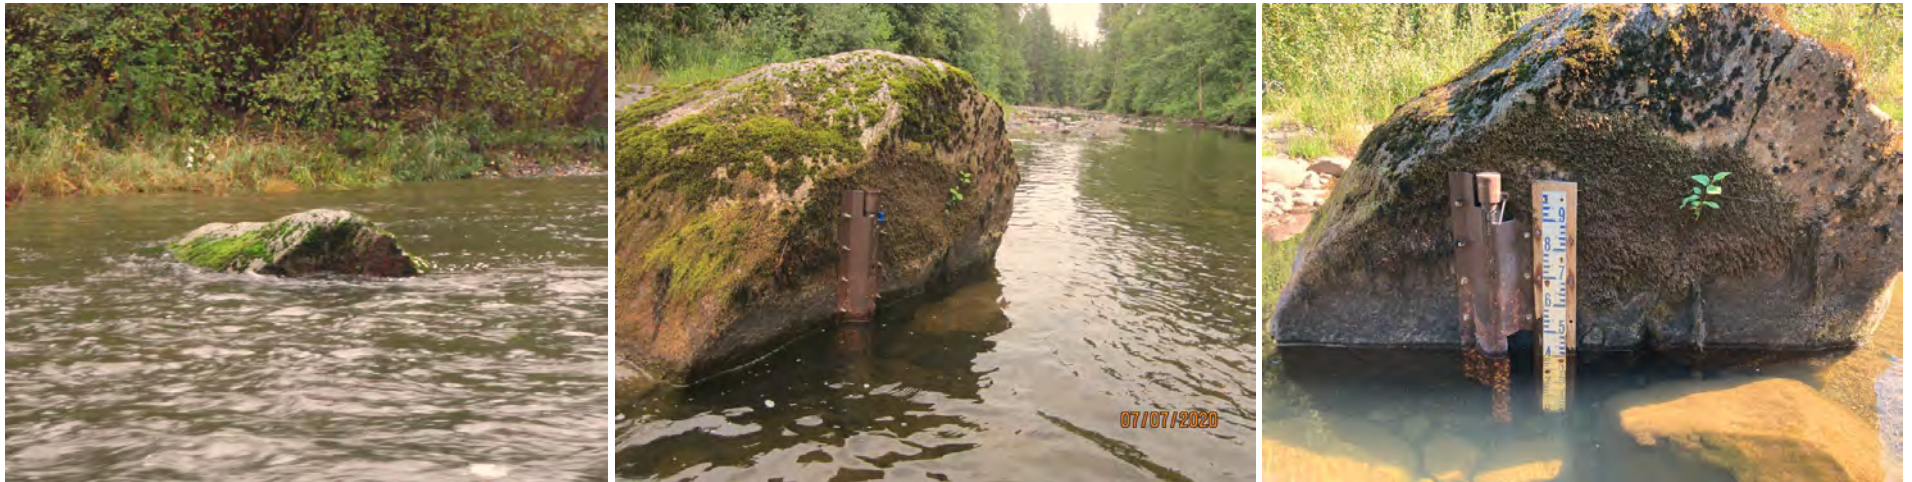
Figure 50. Tsolum River at McNaughton logger location in October 2012, (left), July 2020 (center), and August 2022 (right).
