Vancouver Island Community Flow Monitoring Network Pilot Project

STATION SUMMARIES

2022-23

Prepared by Thea Rodgers, Junior Biologist
British Columbia Conservation Foundation
Nanaimo, BC

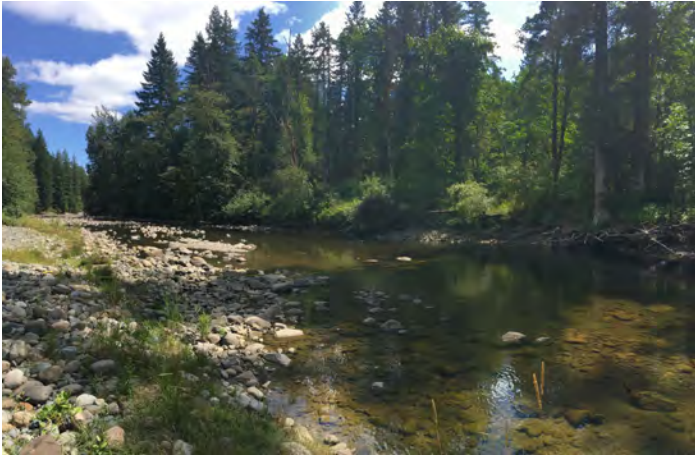
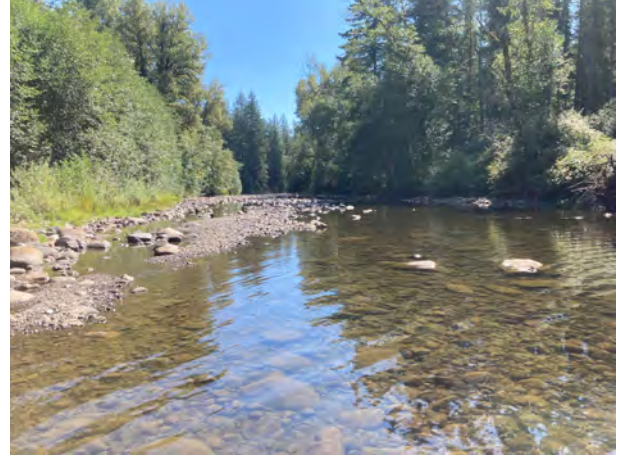
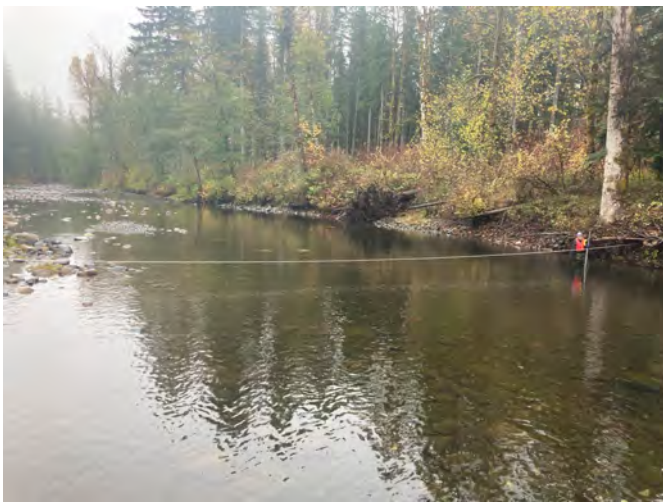
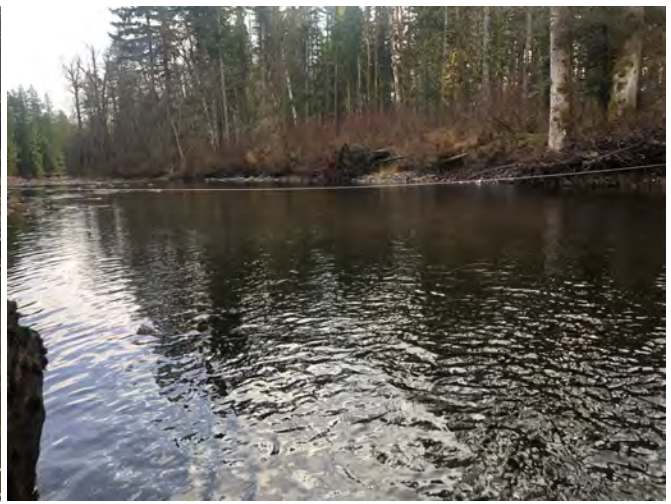
Figure 52. Tsoolum River at McNaughton, looking downstream at control (right bank riffle) from next to station.

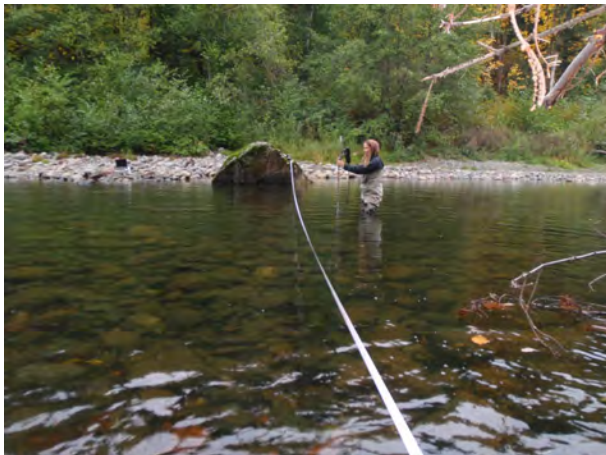
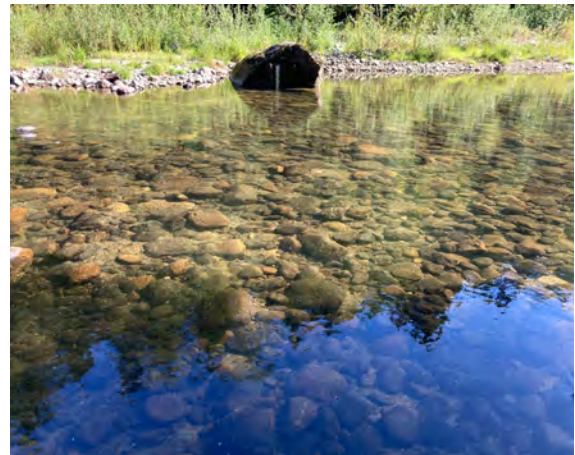
Figure 53. Tsoolum River at McNaughton, looking across from right bank to the boulder where logger is mounted.

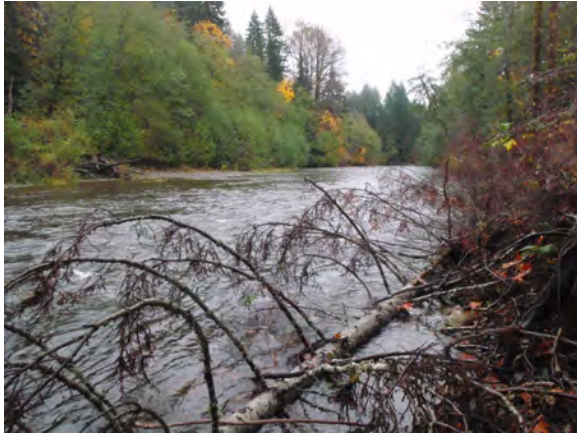
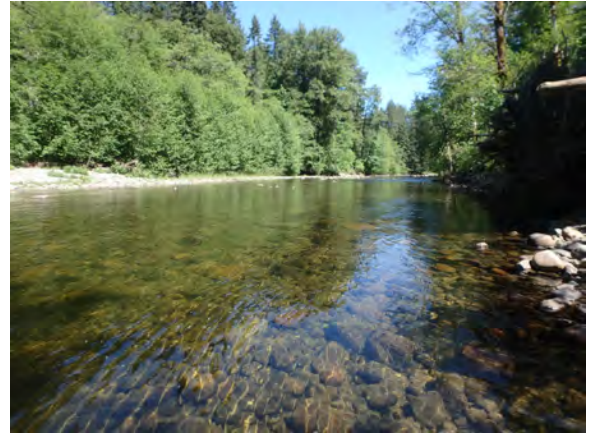
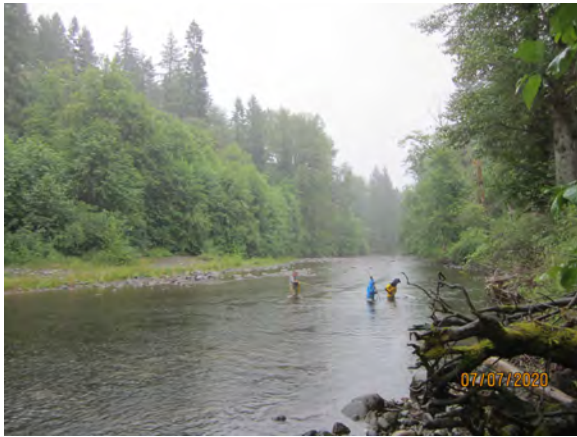
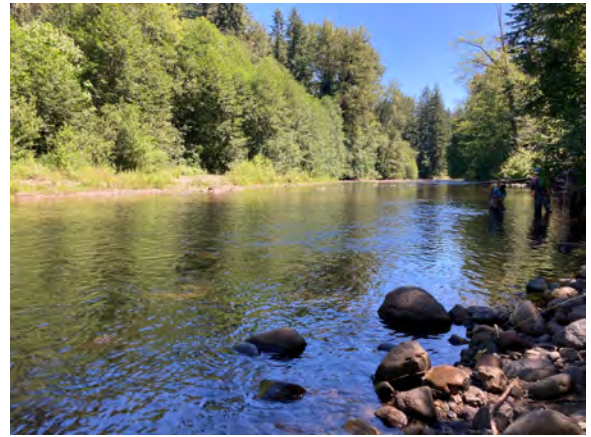
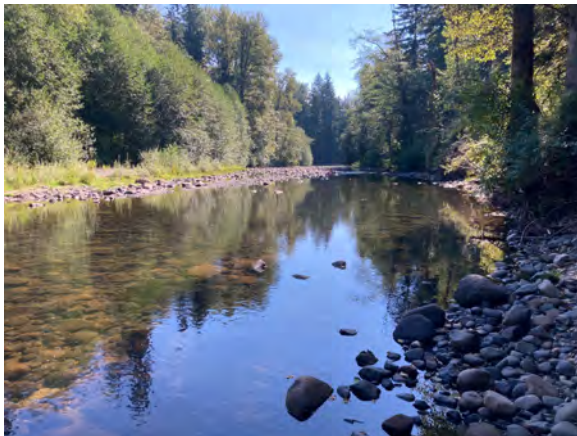
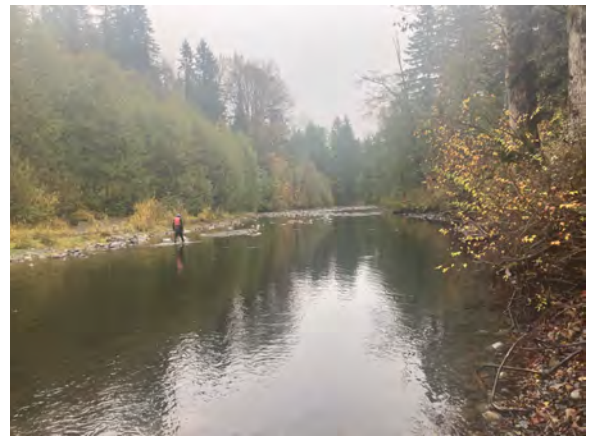
Figure 54. Tsolum River at McNaughton, looking downstream from right bank near walking path.

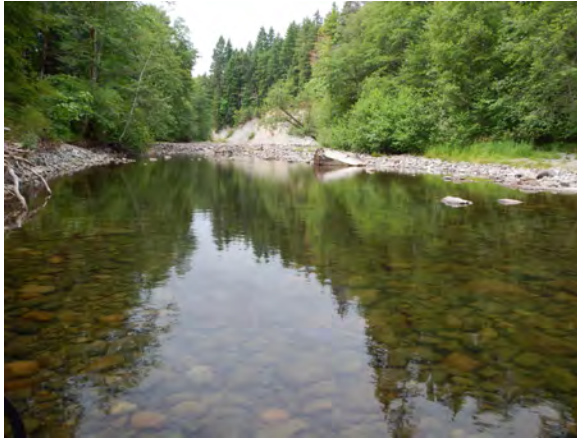
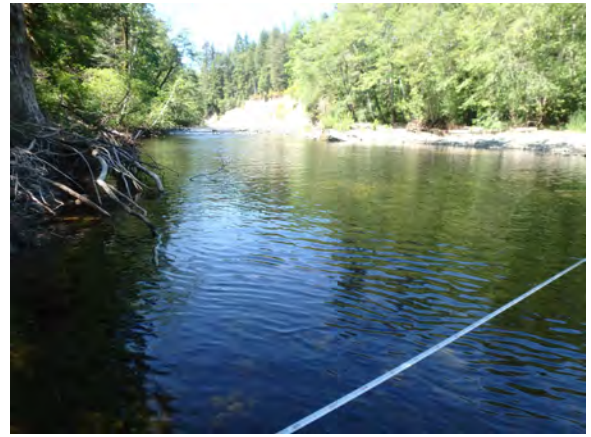
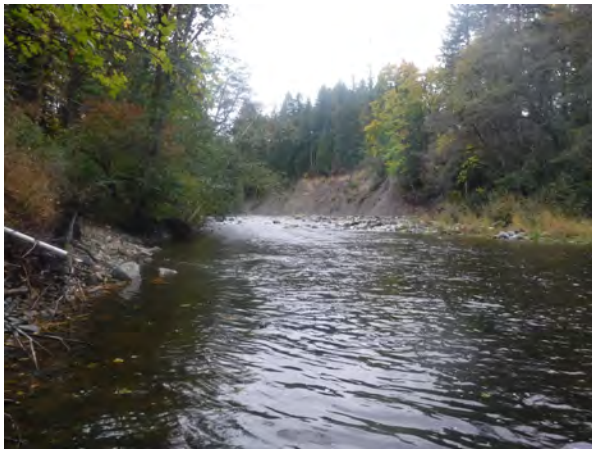
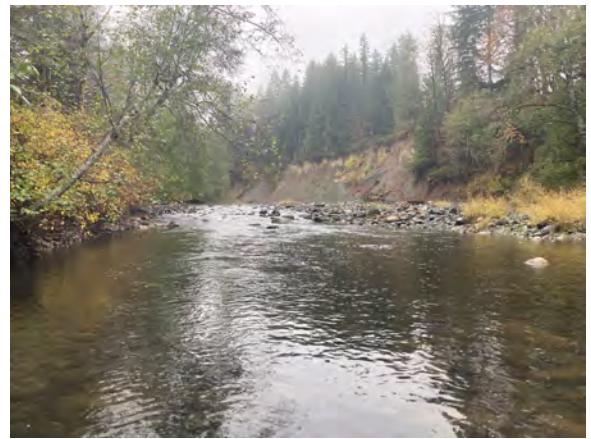
Figure 55. Tsolum River at McNaughton, looking upstream at riffle from right bank near walking trail.

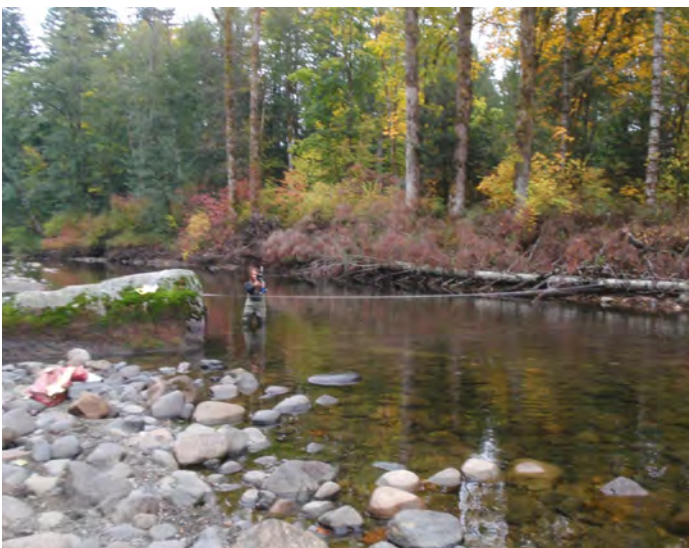
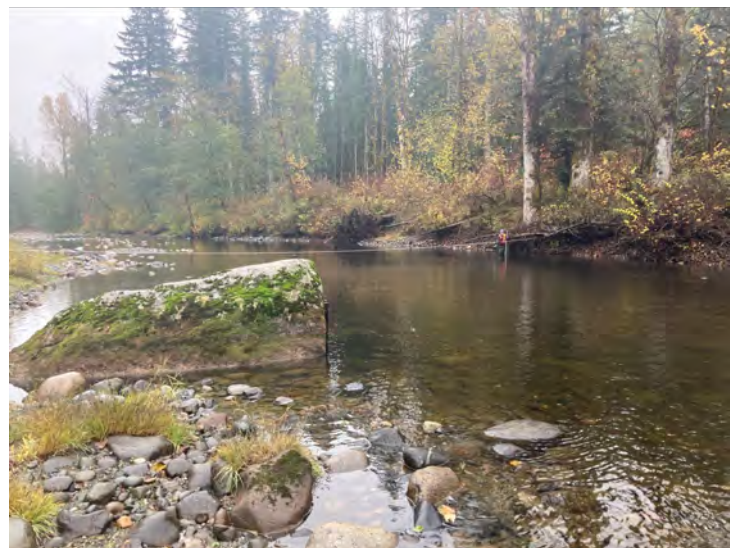
Figure 56. Tsolum River at McNaughton, looking downstream at boulder where logger is mounted.

The site had a staff gauge installed beside the logger in July 2020. Prior to this, there was no stage validation for the site. Four benchmarks were installed in July 2022 and surveyed on the same day. They were re-surveyed within +/- 3 mm of the original established elevations in November 2022. Two of the benchmarks are located upstream of the logger mounted to boulders and can only be accessed under low flow conditions. The primary benchmark is located on top of the boulder where the logger is mounted (Figure 56).
